**Gates Park  
Pack Bridge**

Rocky Mountain Ranger  
District

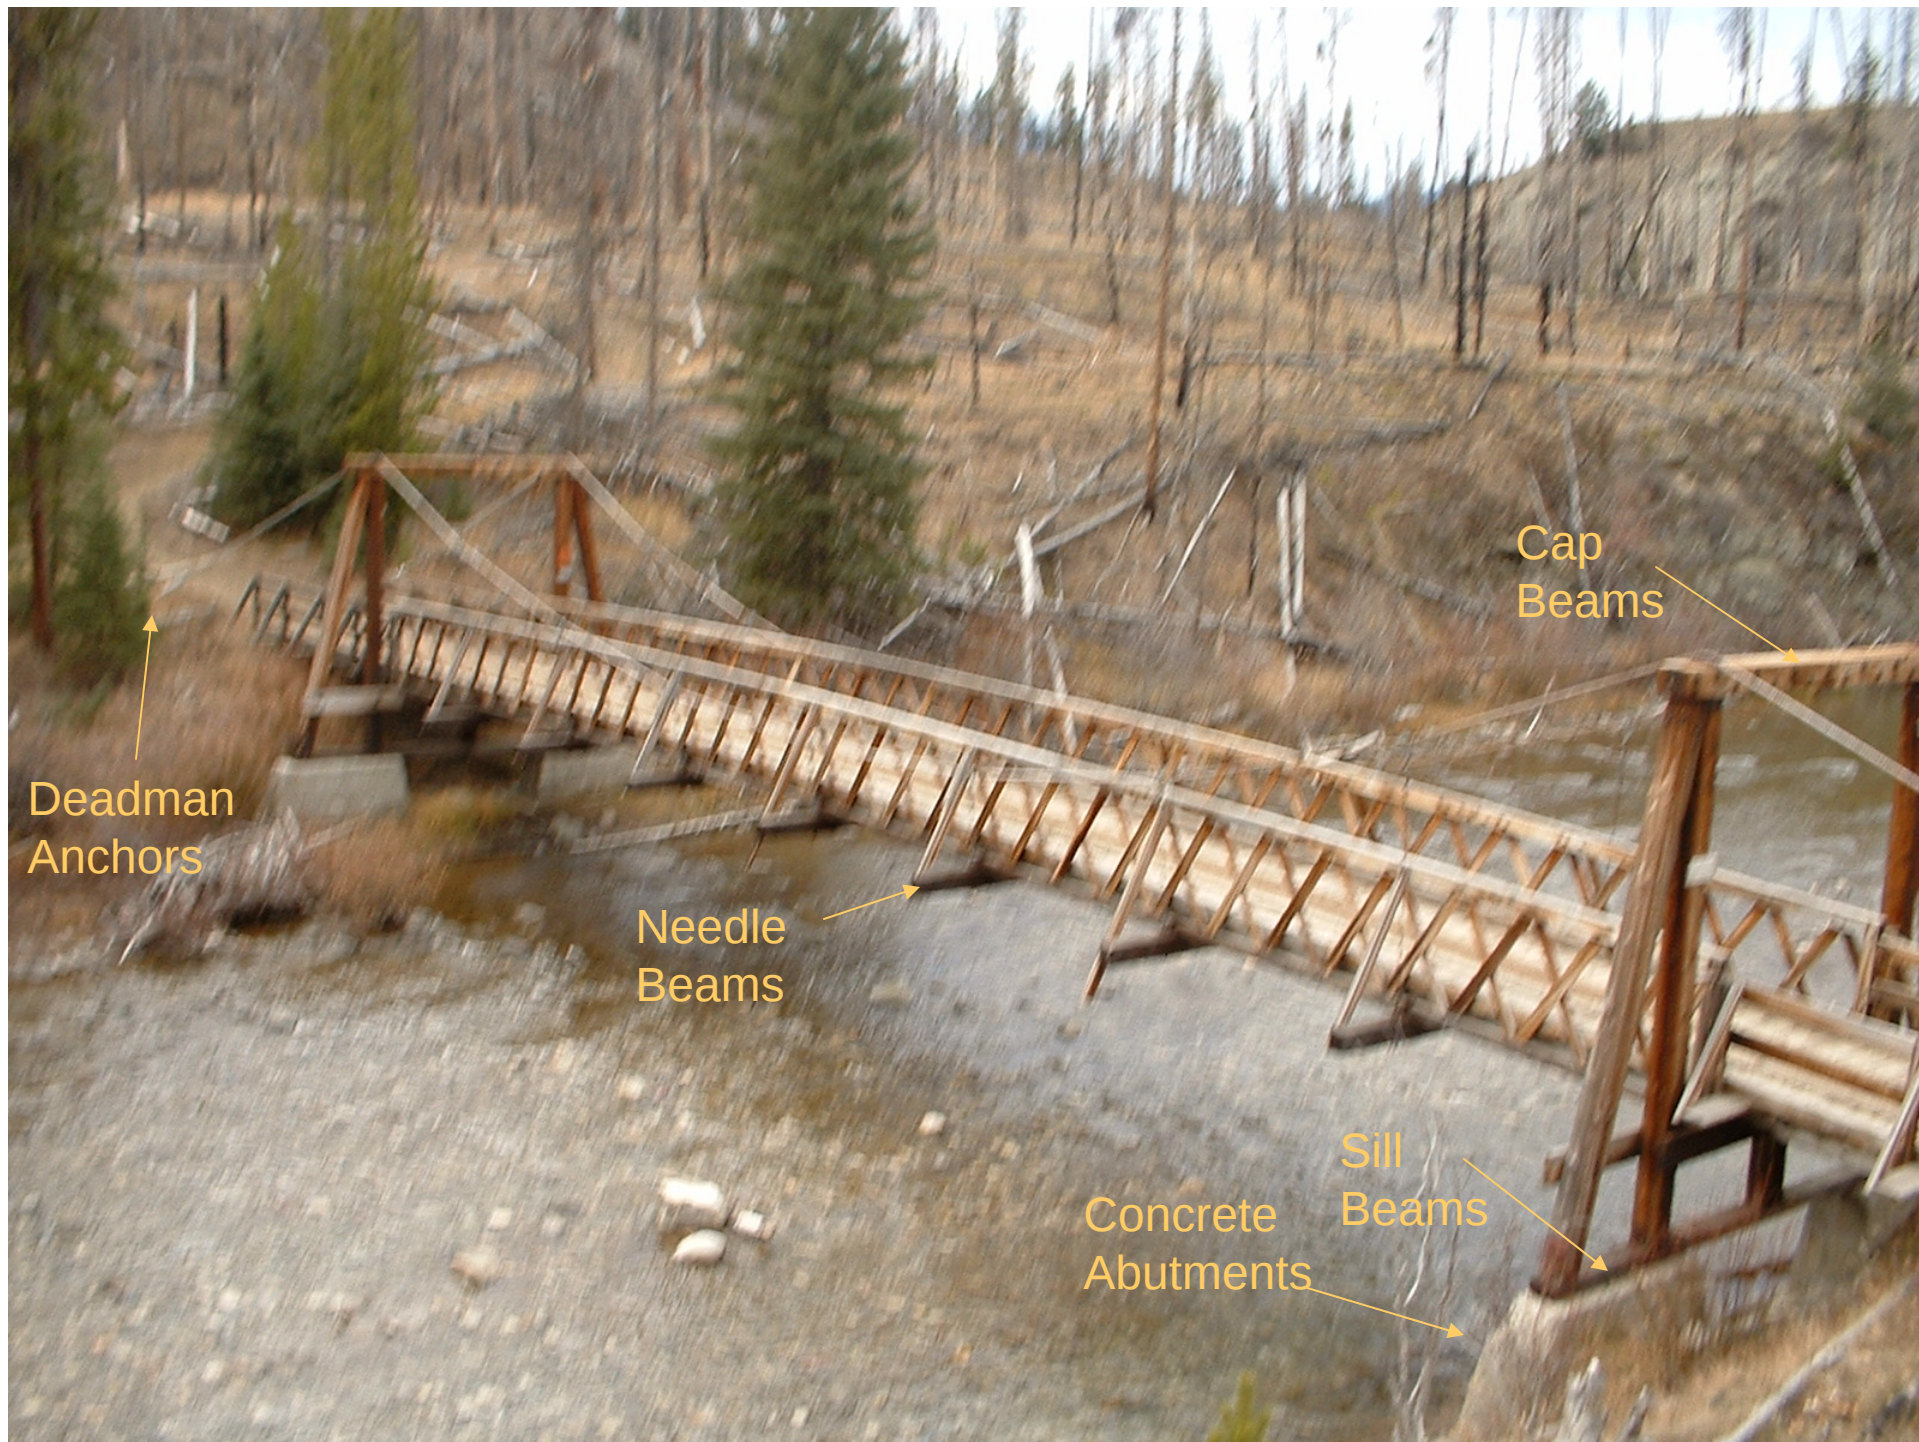
- Under designed for potential snow loads
- Sill beams are crushing
- Concrete abutments deteriorating
- Needle beams (deck supports) listing
- Deadmans (cable anchors) could mobilize

Deadman  
Anchors

Needle  
Beams

Cap  
Beams

Sill  
Beams

Concrete  
Abutments

- In 2000 the caps were replaced.
- Annual inspections to ensure public safety.
- Water bars and check dams installed to prevent erosion around the deadmans.
- Fill hauled and deposited on approaches and over the deadmans.
- Surveyed and benchmarks set to determine listing.
- Started MRDG for the NEPA process.

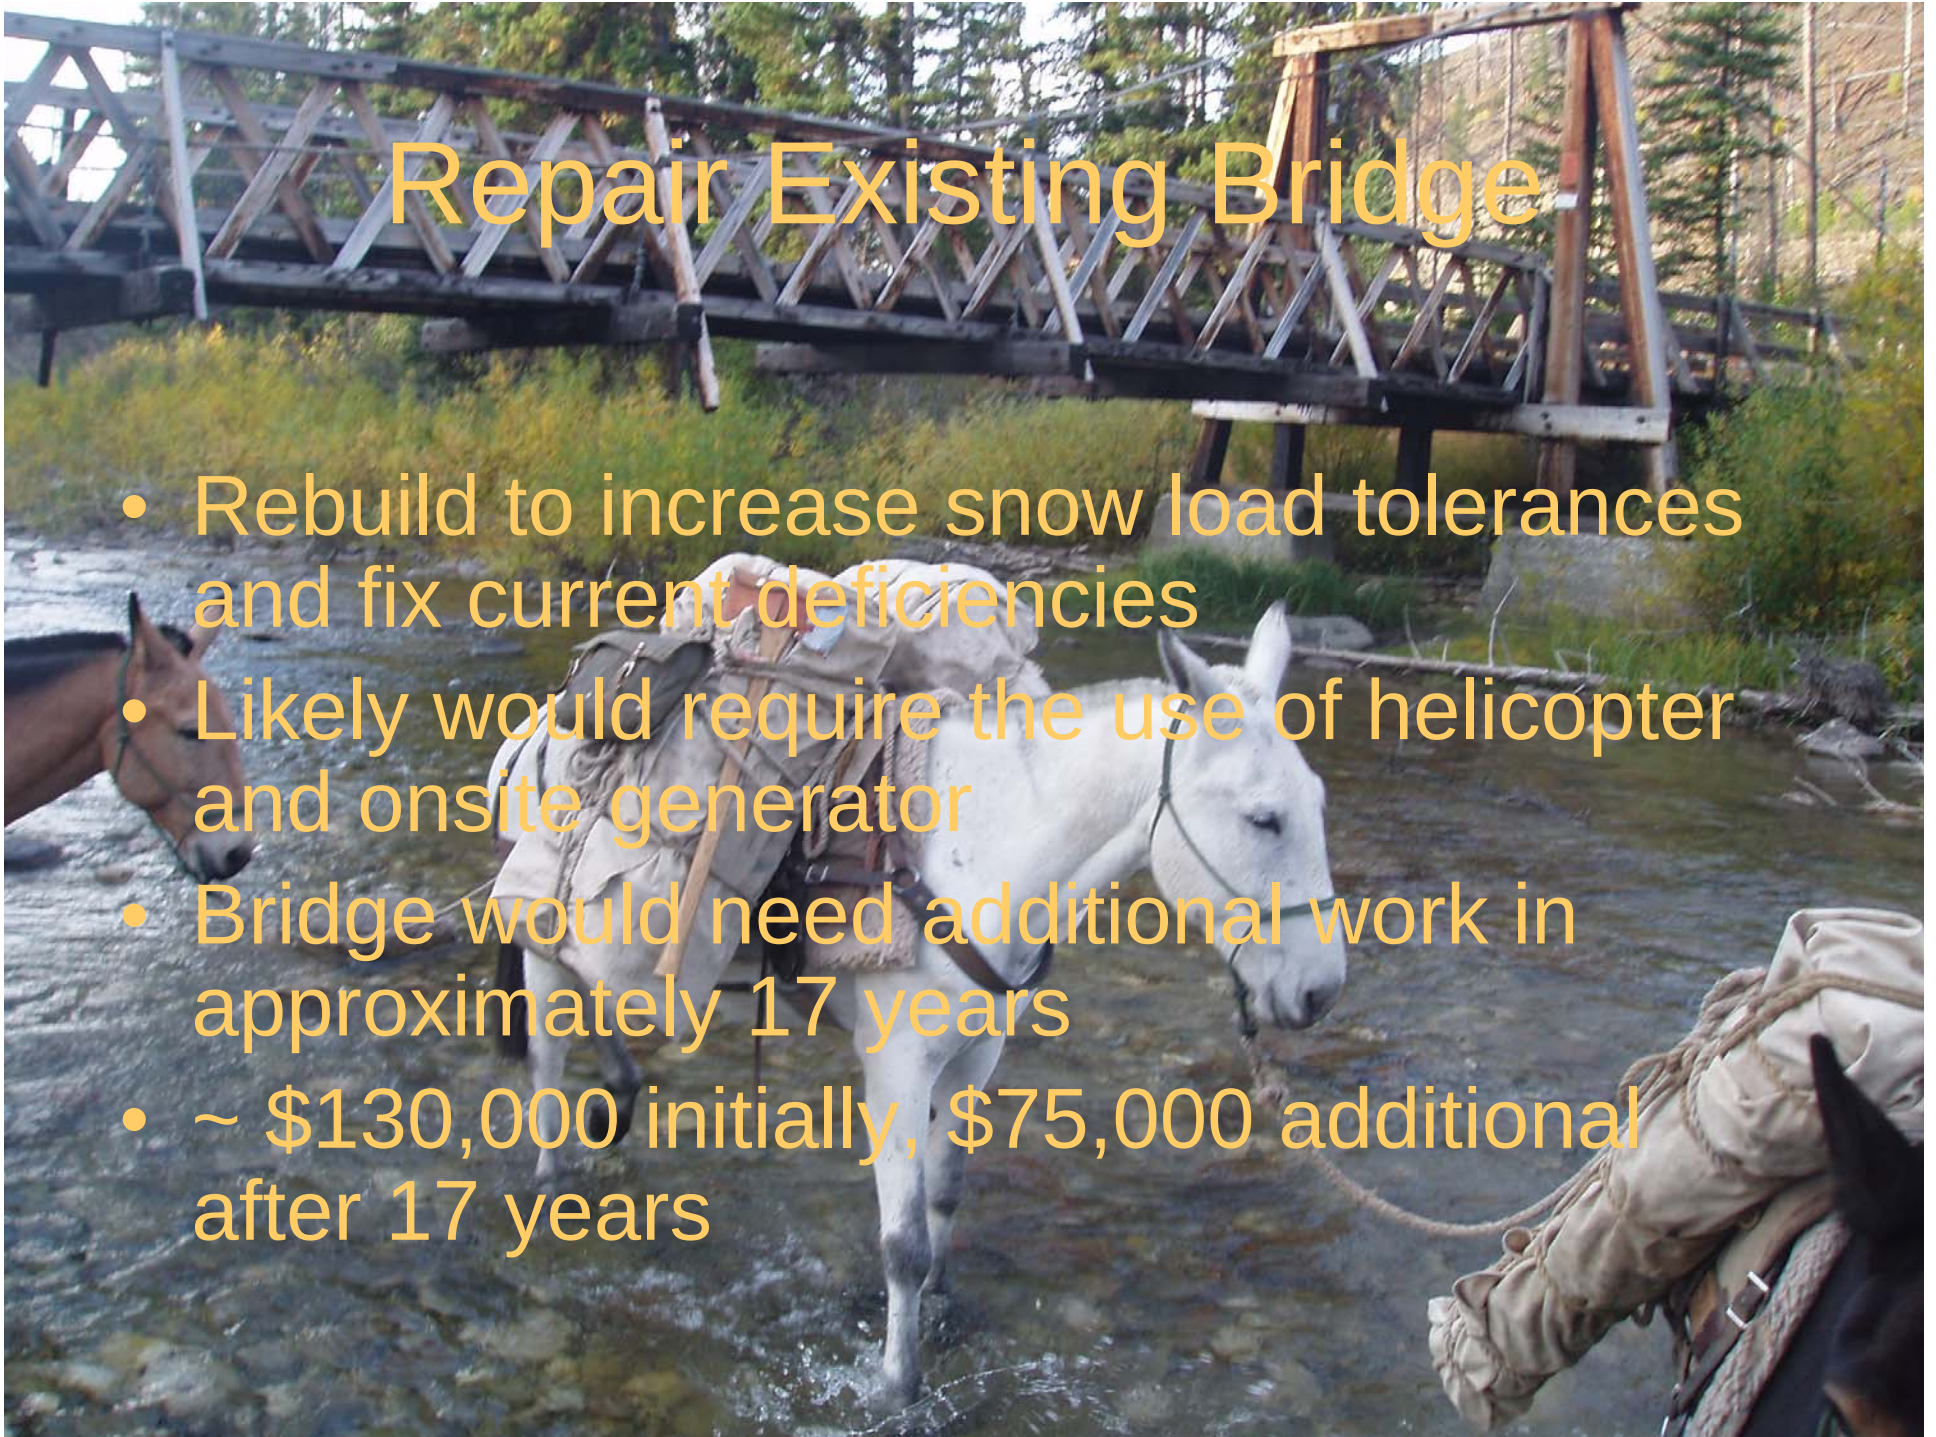
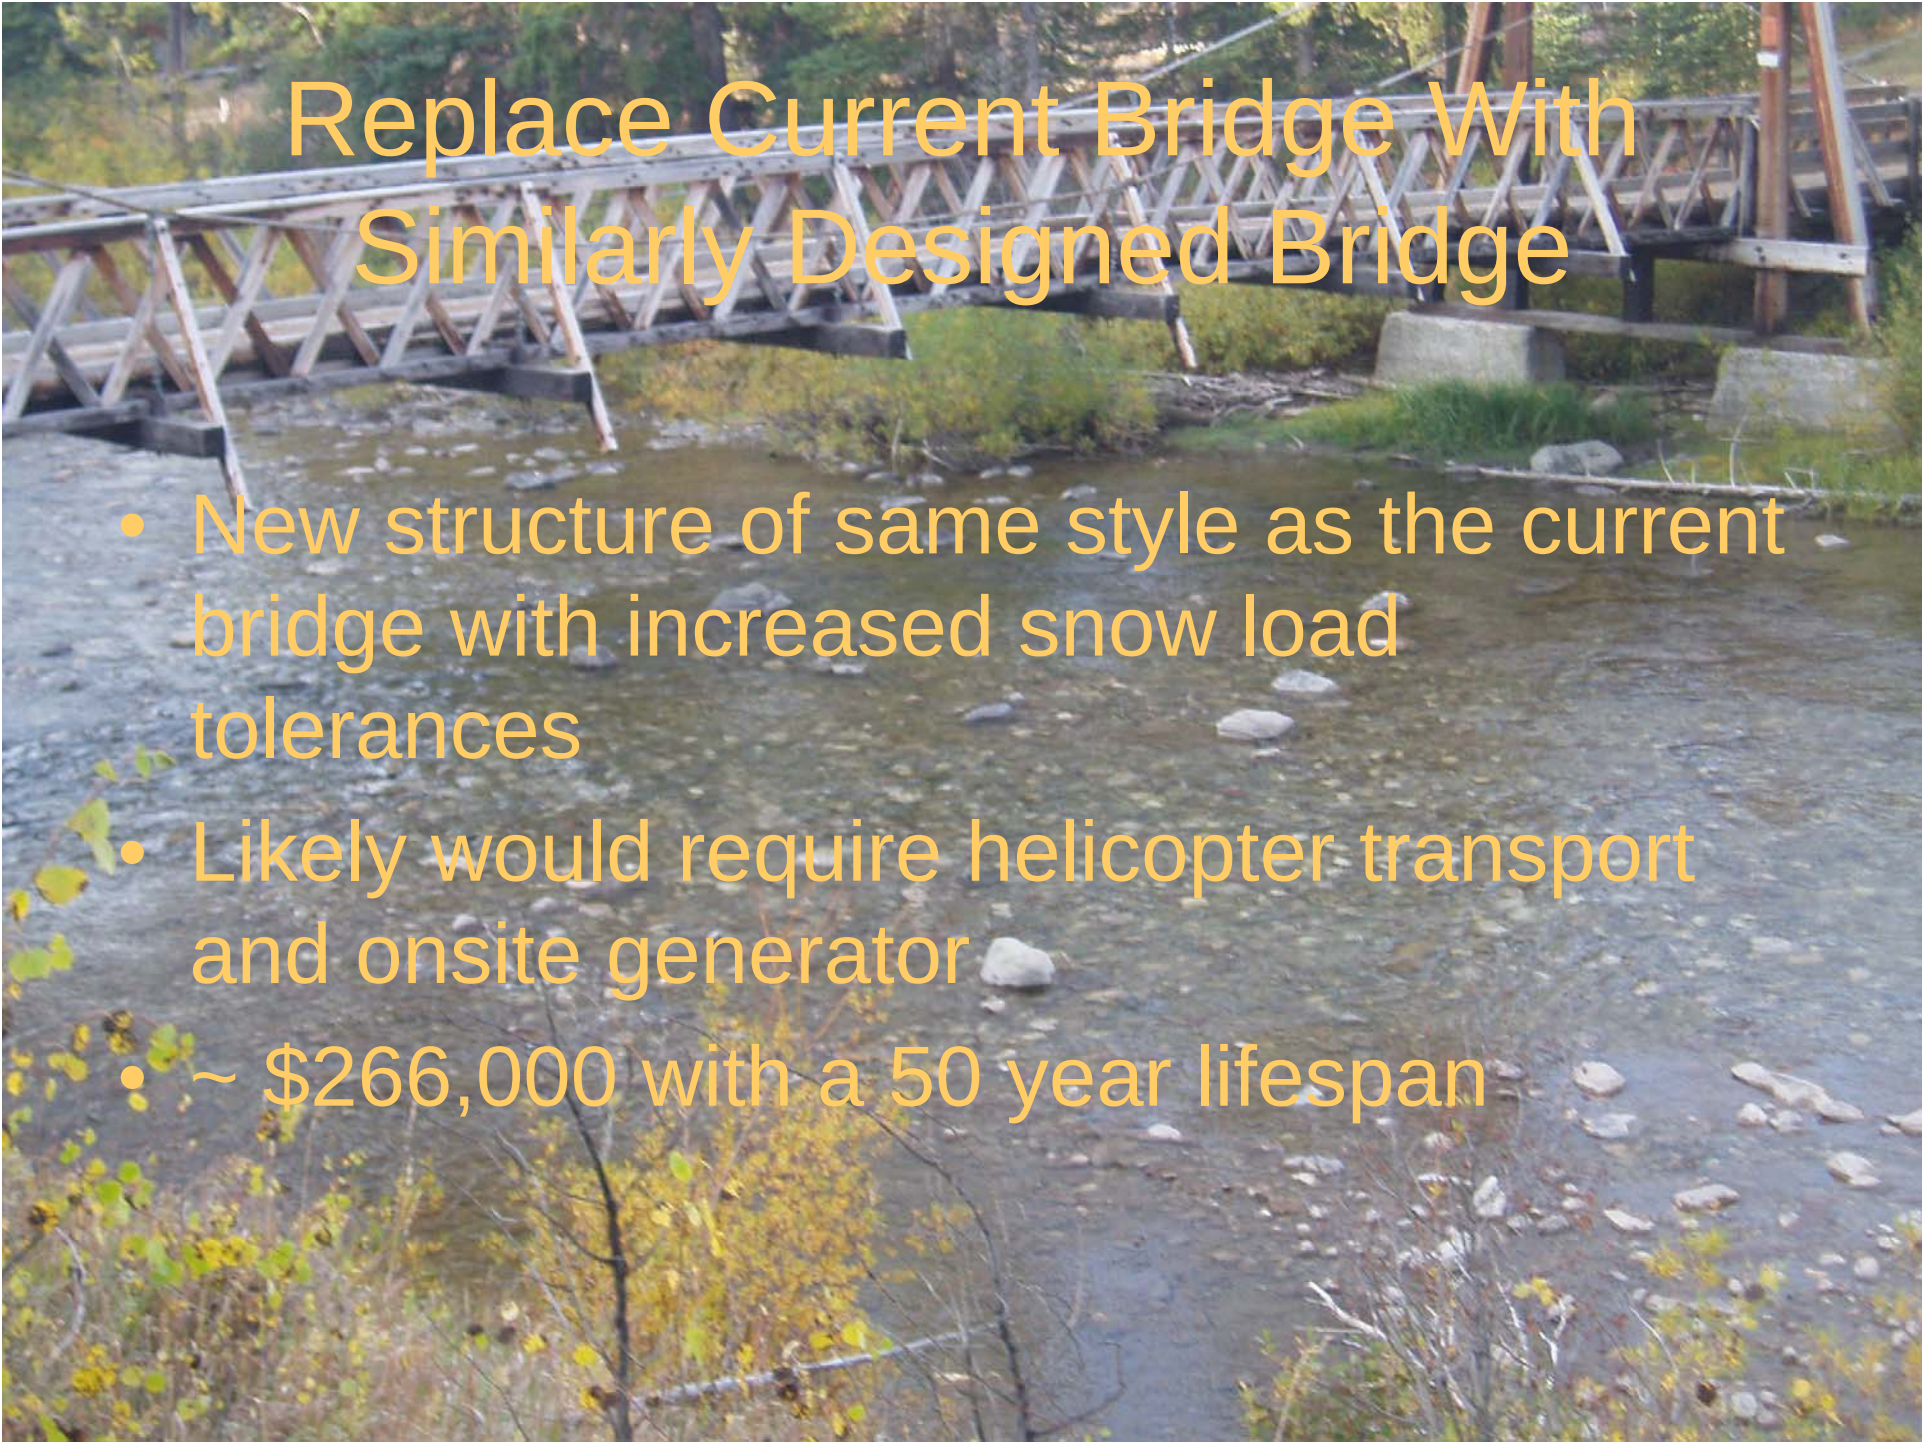
A photograph of a wooden truss bridge spanning a river. The bridge has a complex lattice of wooden beams. In the foreground, there are trees with yellow and orange autumn leaves. The river water is dark and reflects the surrounding environment. The background shows more trees and a hillside.

- Rebuild to increase snow load tolerances and fix current deficiencies
- Likely would require the use of helicopter and onsite generator
- Bridge would need additional work in approximately 17 years
- ~ \$130,000 initially, \$75,000 additional after 17 years

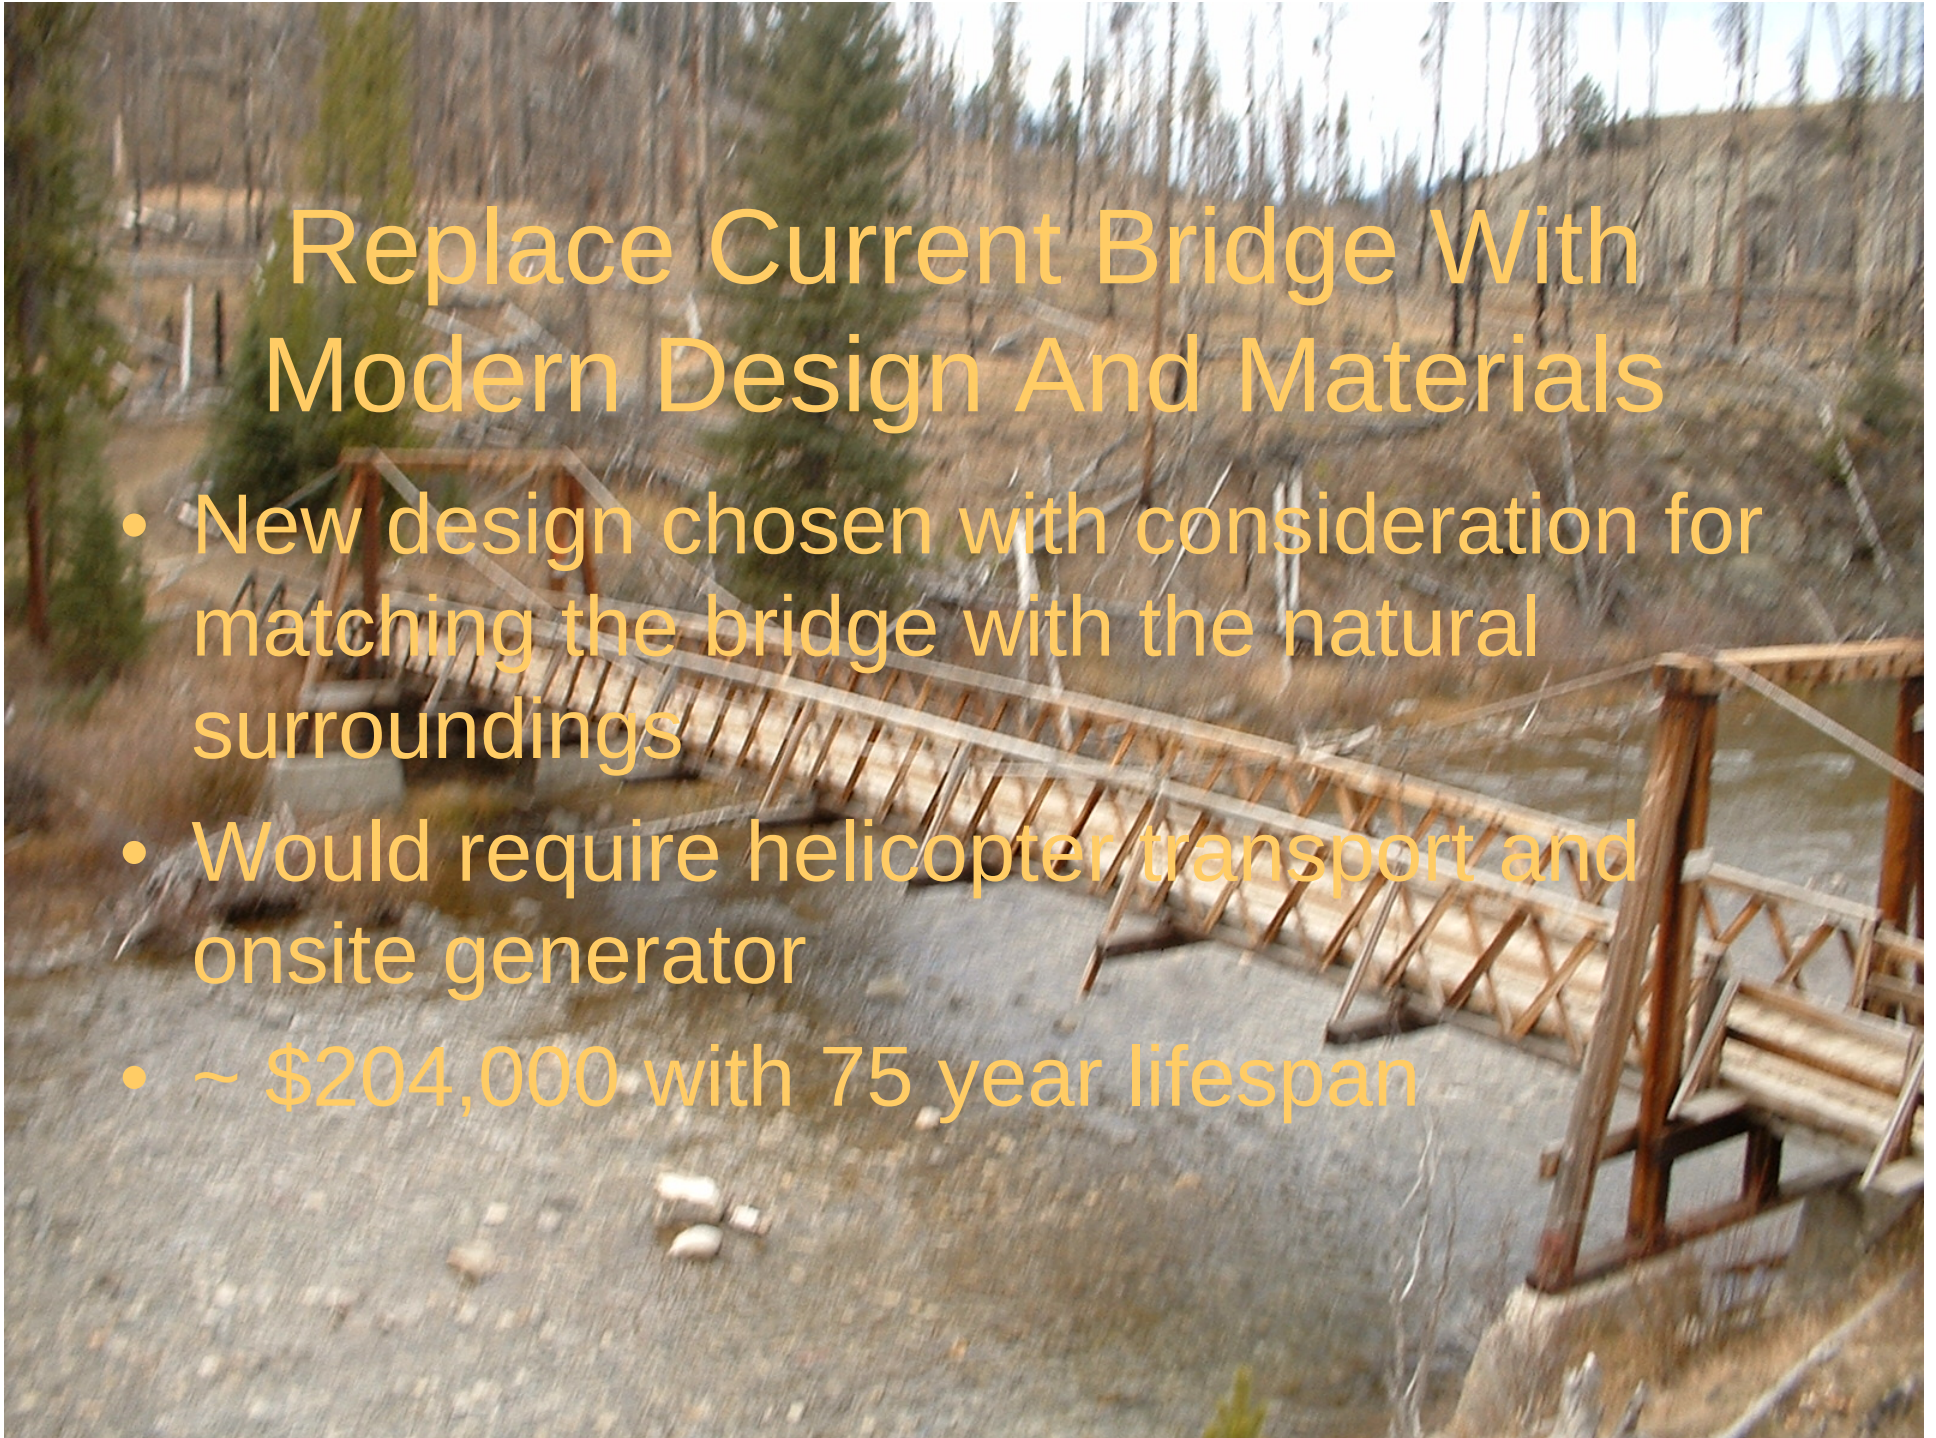
- New design chosen with consideration for matching the bridge with the natural surroundings
- Would require helicopter transport and onsite generator
- ~ \$204,000 with 75 year lifespan

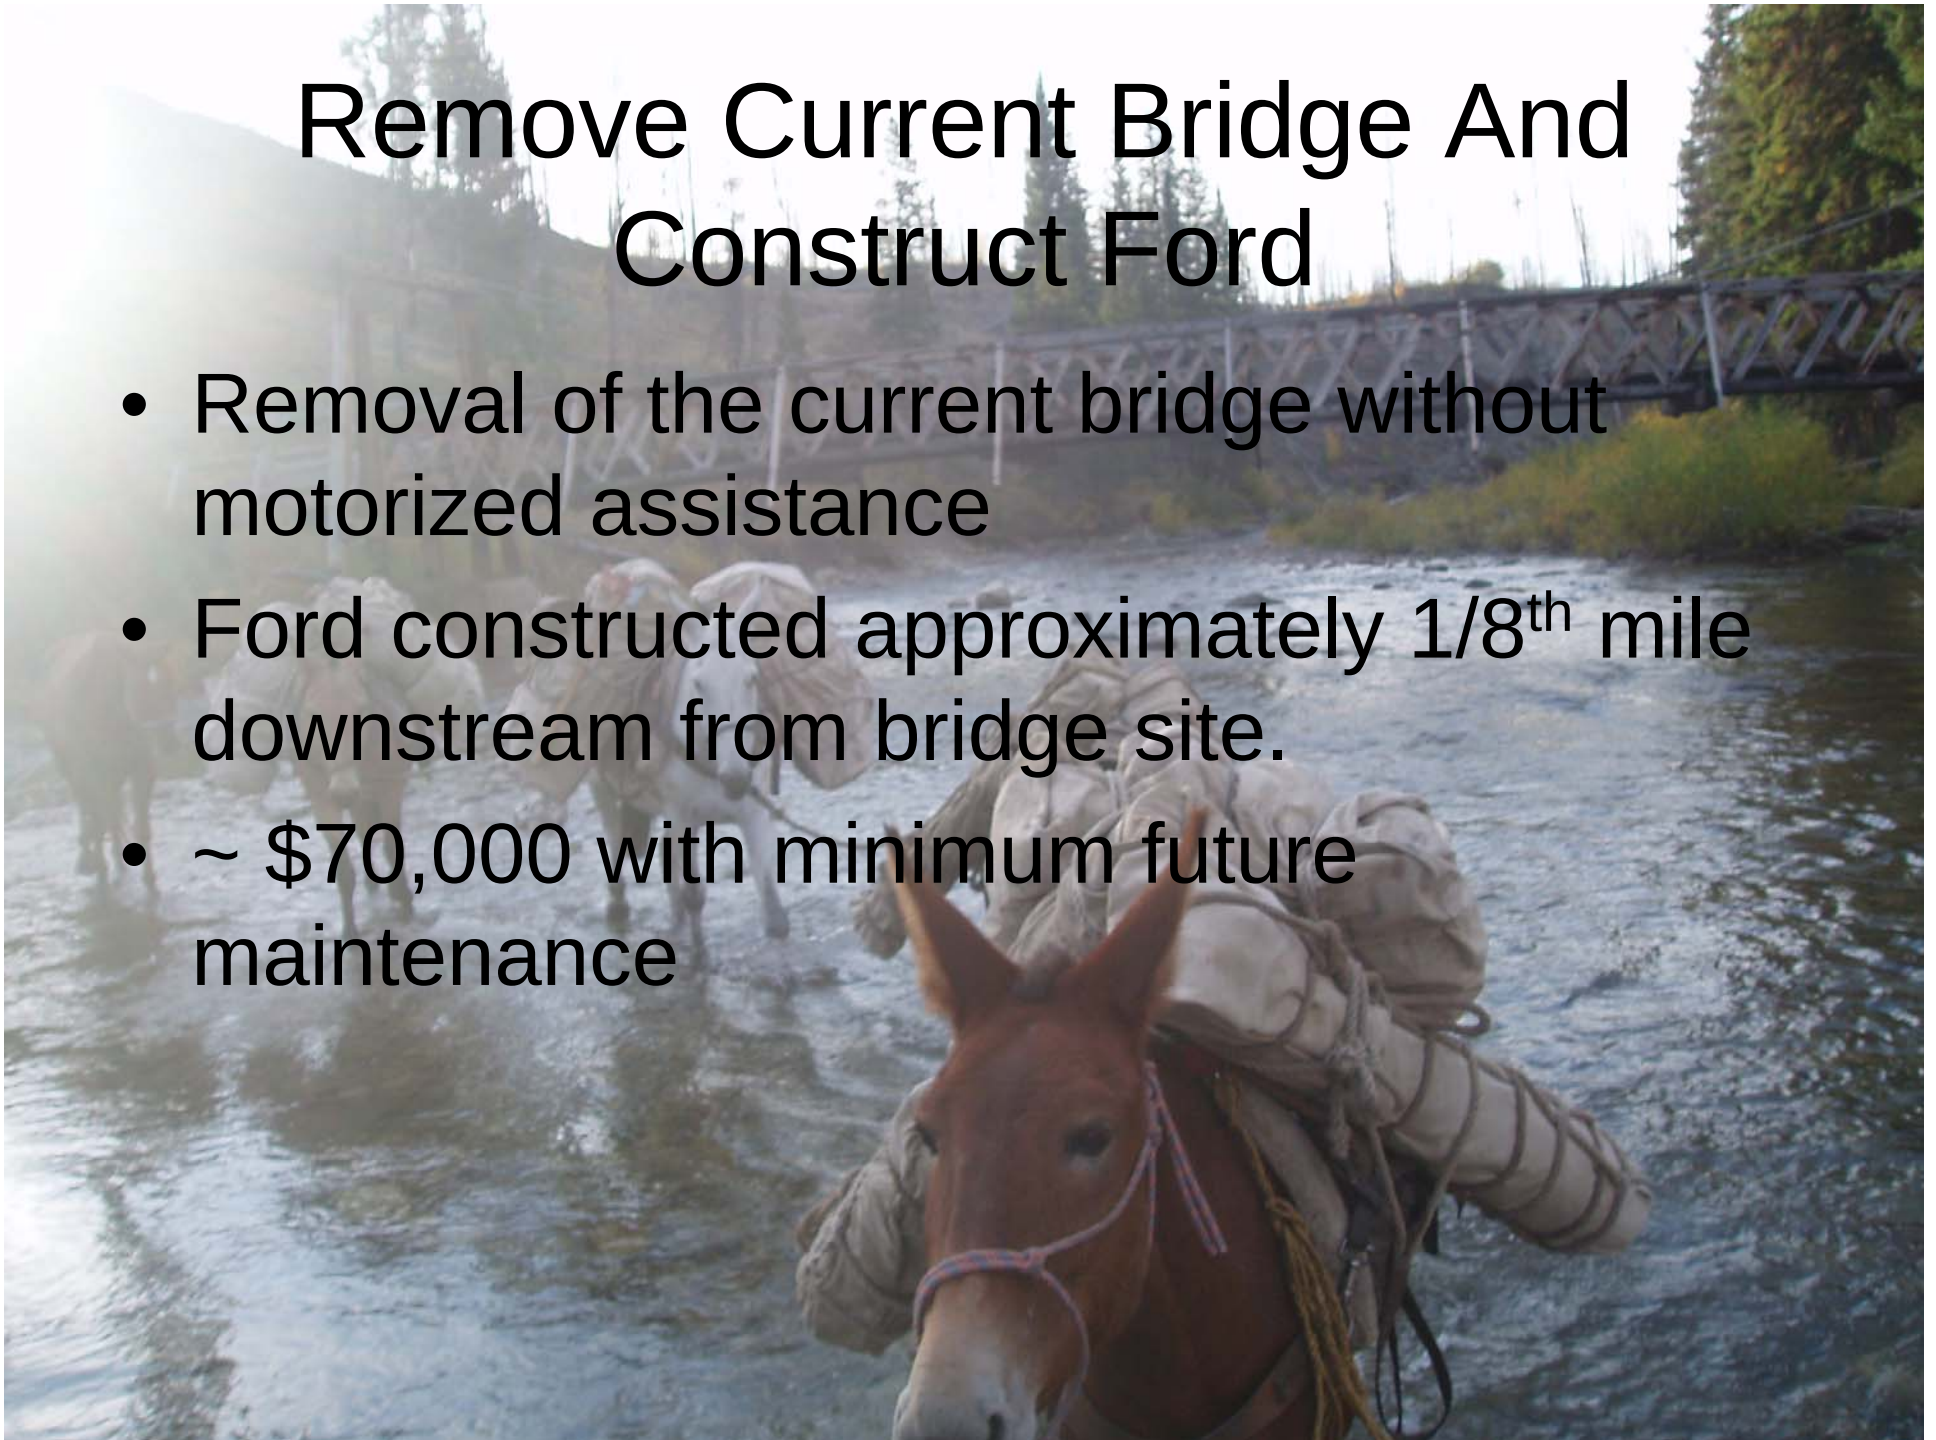
- Removal of the current bridge without motorized assistance
- Ford constructed approximately 1/8<sup>th</sup> mile downstream from bridge site.
- ~ \$70,000 with minimum future maintenance
